Following is our Final Report reflecting Quatro's activities on contract number DAAH01-94-C-R285.

# FINAL REPORT

## AUTOMATED SILICON NITRIDE BEARING BALL INSPECTION STATION

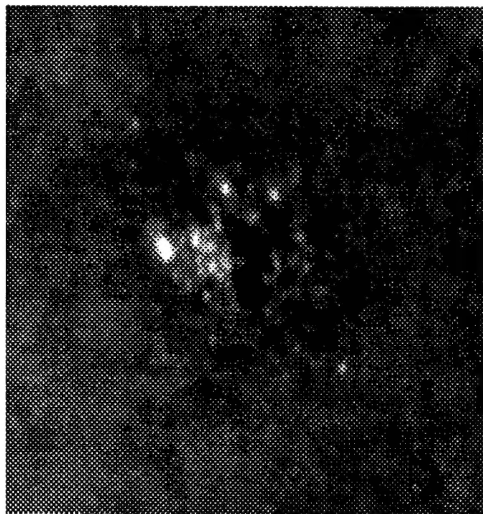
Figure 10. Enlargement of Serious Flaw Found on "Good" Ball

Several times during this project, results of Resonant Inspection indicated that certain silicon nitride bearing balls which were thought to be flawless actually had surface flaws. Subsequent microscope investigation (10X - 40X) *confirmed the existence of flaws* on several of these "acceptable" balls. One of the more severe of these flaws shown in Figure 10. This flaw was found to be 175  $\mu\text{m}$  across (about 0.007").
